City of Chattanooga
DEPARTMENT OF PUBLIC WORKS
DEVELOPMENT RESOURCE CENTER
ENGINEERING DIVISION
1250 MARKET STREET, SUITE 2100
Chattanooga, Tennessee 37402-2713

March 3, 2014

**Re: Written Warning
NPDES/Stormwater Compliance Inspection
NPDES TMSP#TNR051467**

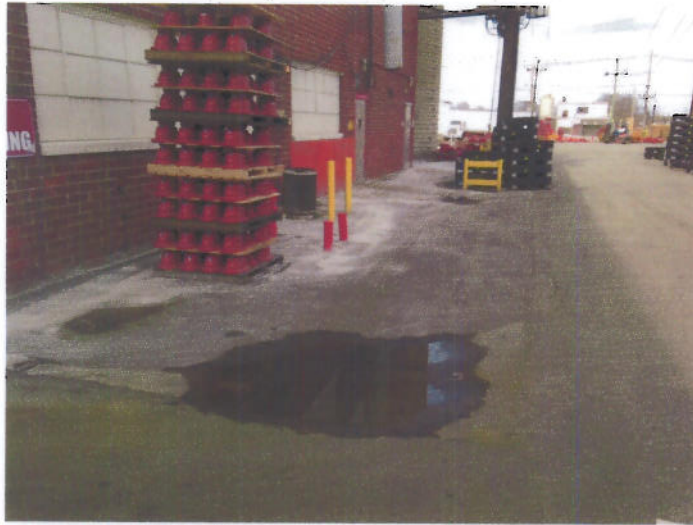
- Drums and other liquid container are not being stored properly. One was observed collecting stormwater runoff.
- General housekeeping around the facility needs some improvement. The pavement in several areas around the baghouse collectors were found with excessive accumulation of dust.
- Hazardous Waste collection vessel has a defective covering mechanism to prevent contact with stormwater runoff.
- Two used oil collection vessels must have some form of secondary containment.

Fig 1. Poor Housekeeping Measures

- **Within 30 days** from receiving this letter:
 - Develop a **Corrective Action Plan** that will address the issues mentioned in this Written Warning letter. The plan shall be submitted to this office within 30 days of receiving this letter.
 - Implement a dredging schedule on retention pond and surrounding drainage conveyances to prevent excessive accumulation of the foundry sand.

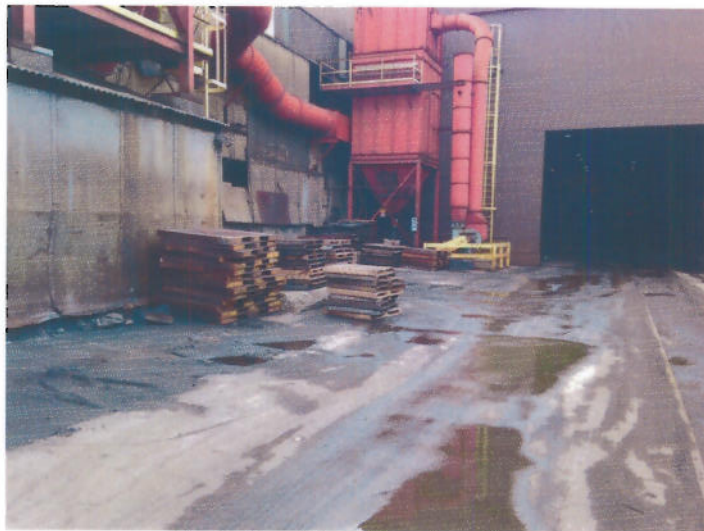
Fig 2. Poor Housekeeping Measures

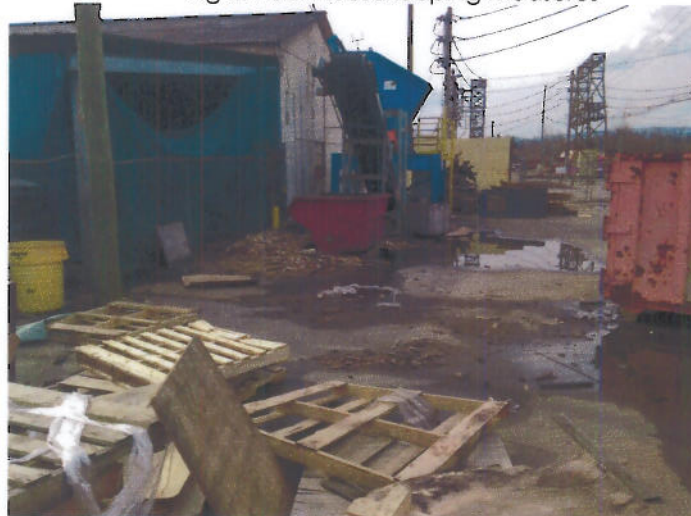
Fig 3. Poor Housekeeping Measures

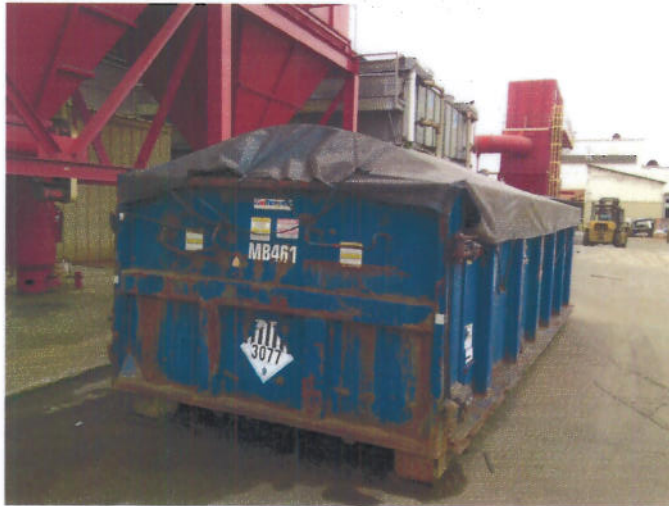
Fig 4. Hazardous Waste Vessel- Ripped Tarp

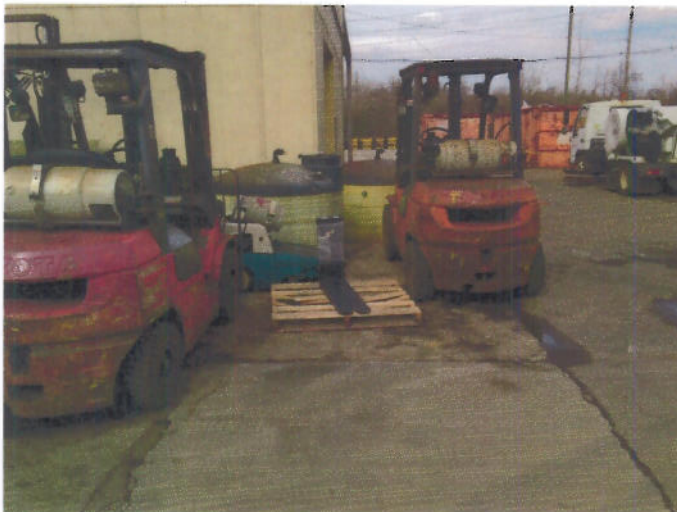
Fig 5. Used oil containers- No secondary containment

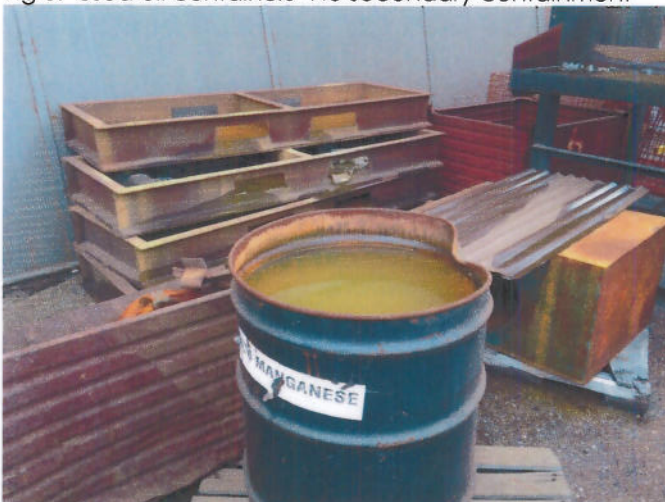
Fig 6. Drum collecting stormwater runoff

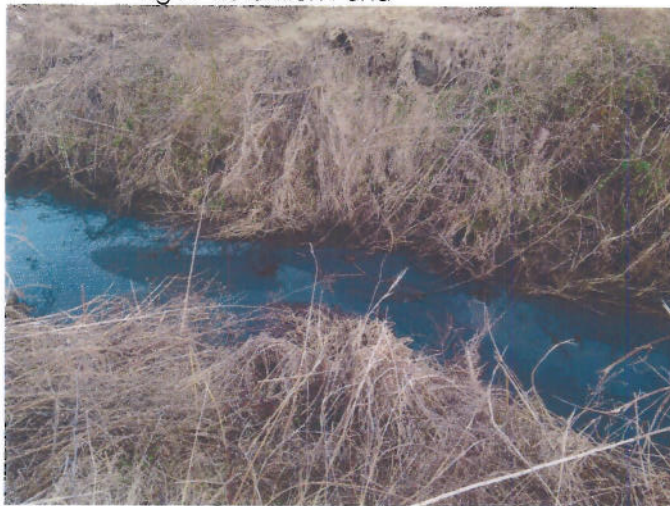
Fig 8. Retention Pond drainage conveyance- sand accumulation

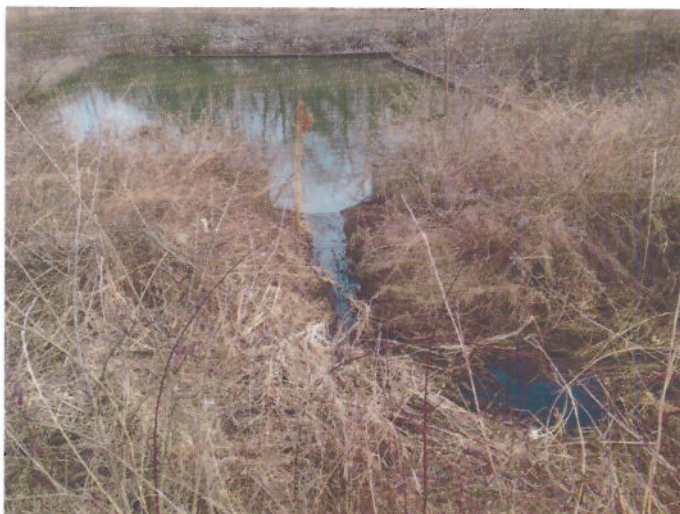
Fig 9. Retention Pond primary drainage conveyance- sand accumulation

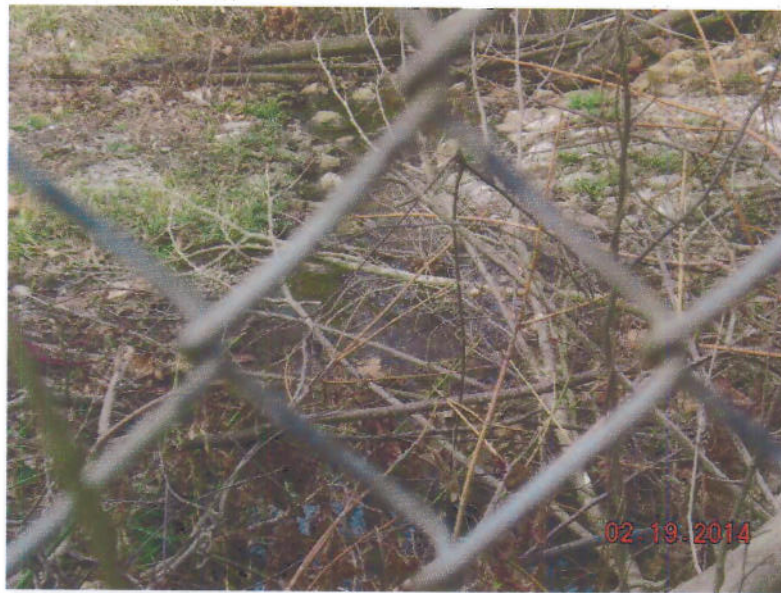
- Some Styrofoam pellets were observed on the pavement in northeast corner of the property.
- Stormwater controls (filter socks) are in need of maintenance around **Outfall #1**. Properly functioning BMPs will help prevent any excess sediment or foundry sand runoff from facility from entering South Chickamauga Creek.

Fig 10. Stormwater Controls in need of maintenance at **Outfall #1**
